## INFRARED ROOF MOISTURE SURVEY

**Spectrum Infrared Services, Inc.**  
17 Elm Street, Allendale, NJ 07401  
551-404-2325  
[www.SpectrumIRServices.com](http://www.SpectrumIRServices.com)

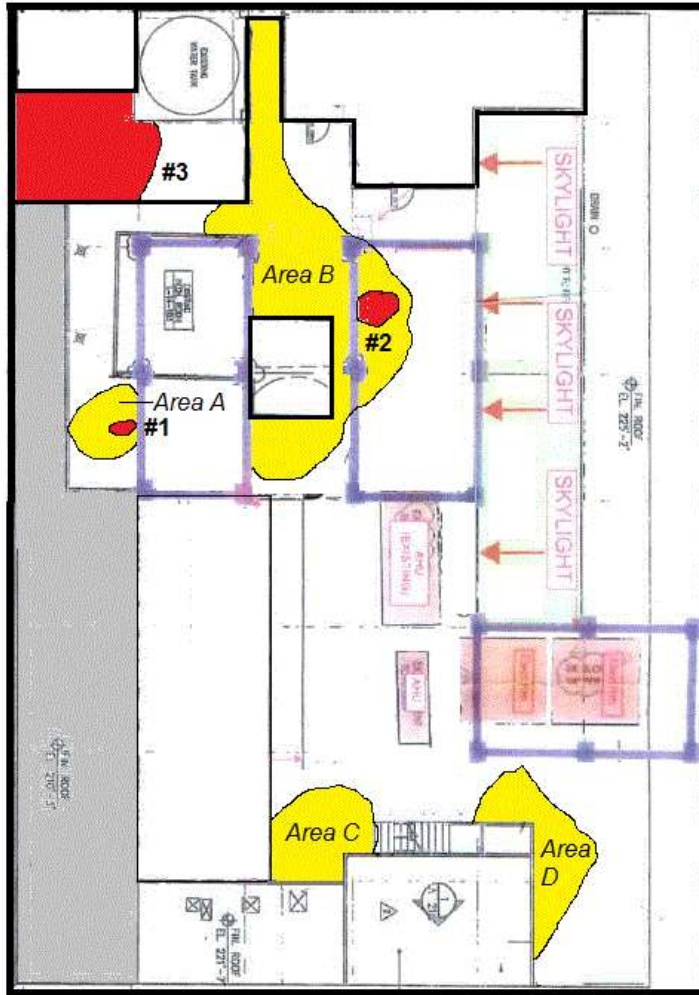
A roof drawing is presented prior to the thermograms and photos, depicting the roof layout, and the location of the moisture damaged anomalies, if any.

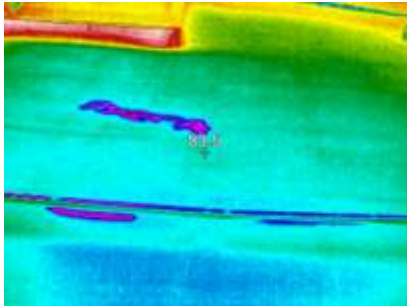
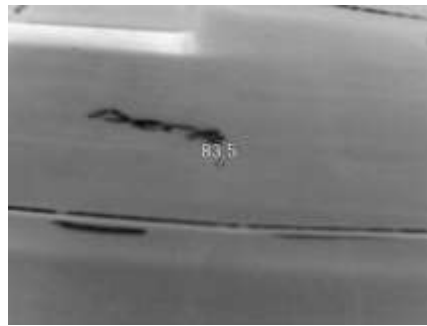
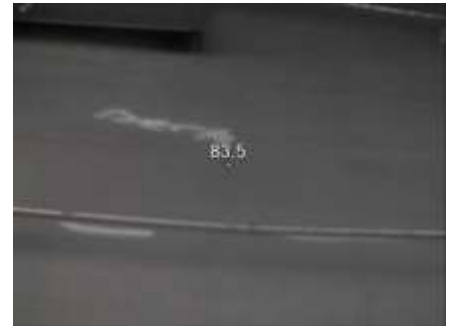
**Area C**

**Comments:** Although wet insulation is not seen with the infrared camera, the Tramex Moisture Meter detected moisture down on the decking, 4” below the surface.

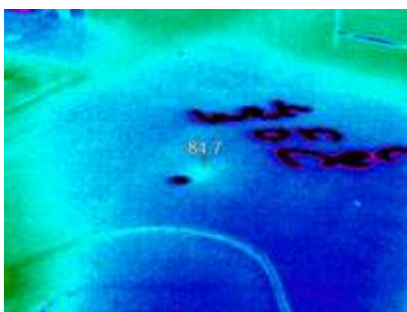
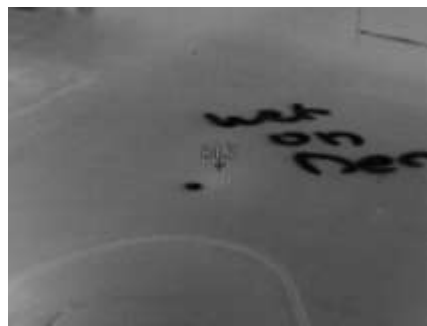
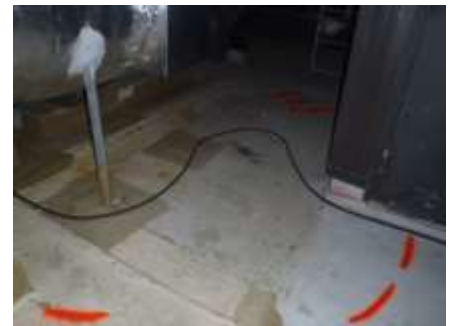
**Area D**

**Comments:** Damage to the membrane, repaired with caulking was seen at this area. Moisture was detected with the Tramex Moisture Meter. Insulation appears to be dry at this time.
