**INFRARED ANALYSIS
OF THE
ELECTRIC SERVICE PANELS**

An infrared, electrical component analysis was conducted at [REDACTED], by **Spectrum Infrared**. The survey was made on June 27, 2016, for the purpose of locating and defining increases in surface temperatures within power supply panels. All circuit breakers panels, and fuses in electric service panels were scanned.

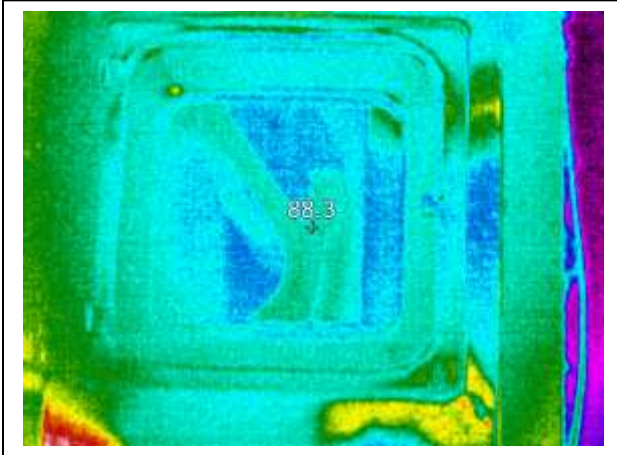
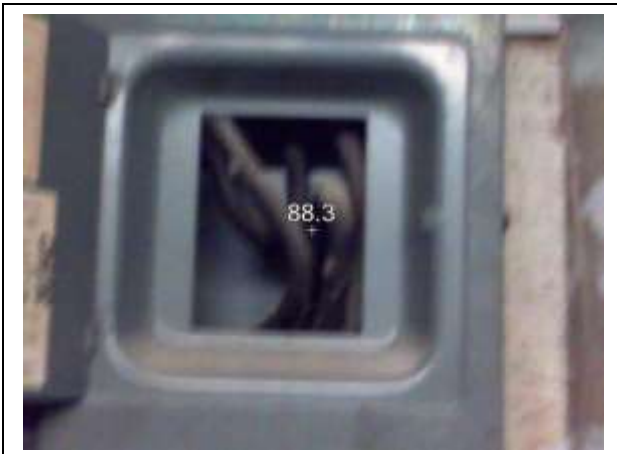
Thermographic Set #: 1
Location: Laundry Room
Panel: Junction Box
Circuit/Fuse Designation: Wires
Anomaly Temp: --
Ambient Temp: 88 F
Temperature Differential: --
Priority Scale: x

Comments: No increases in surface temperatures noted within this junction box.

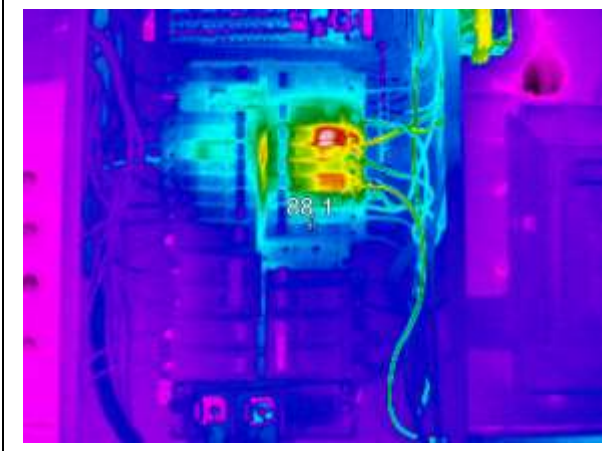
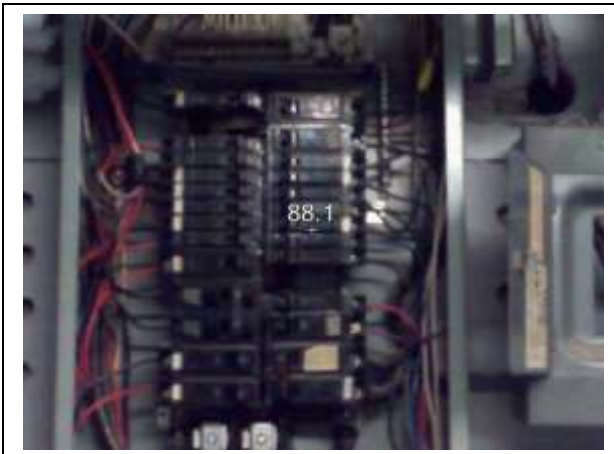
Thermographic Set #: 2

Location: Laundry Room

Panel: Main Lighting

Circuit/Fuse Designation: #6, #12

Anomaly Temp: 100.7 and 97 F

Ambient Temp: 86 F

Temperature Differentials:

#6- 14.7 F

#12- 11 F

Priority Scale: 3

Comments: Minor increases at lighting panels.

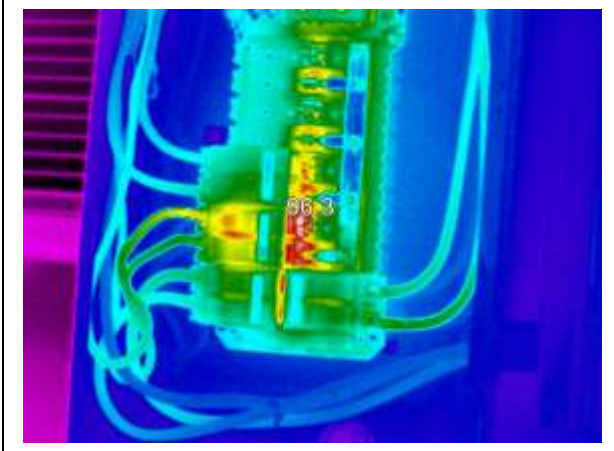
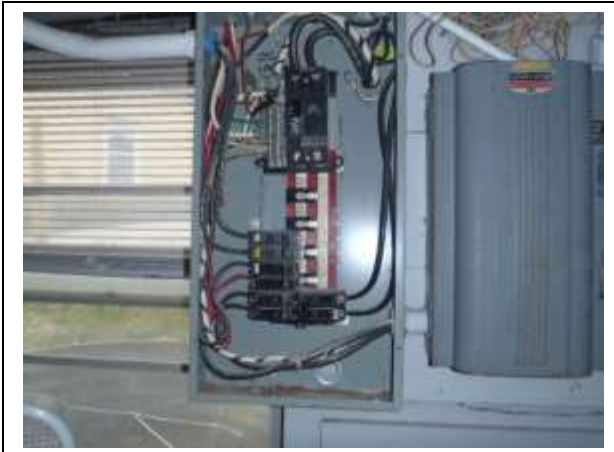
Thermographic Set #: 3

Location: Laundry Room

Panel: Main Disconnect

Circuit/Fuse Designation: Kitchen
Breaker

Anomaly Temp: 103.7 F

Ambient Temp: 82 F

Temperature Differential: 21.7 F

Priority Scale: 2

Comments: Increased loads with normal kitchen use.

Special attention should be made at anomalies with temperatures of 20 degrees or more above ambient temperatures. Connections should be tightened and amp readings taken, to be sure the circuit is not overloaded. If an overload is determined, the usage of the circuit should be re-directed.

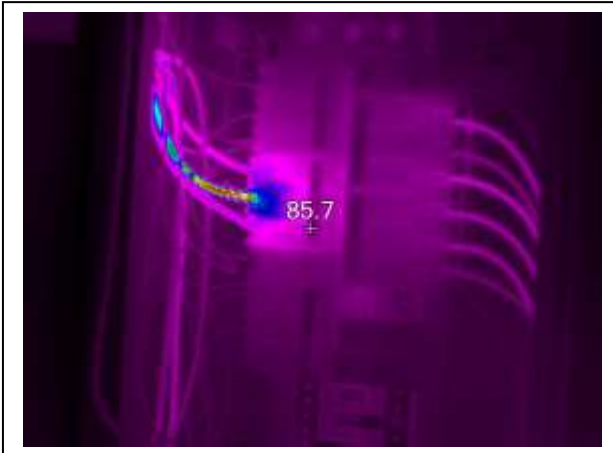
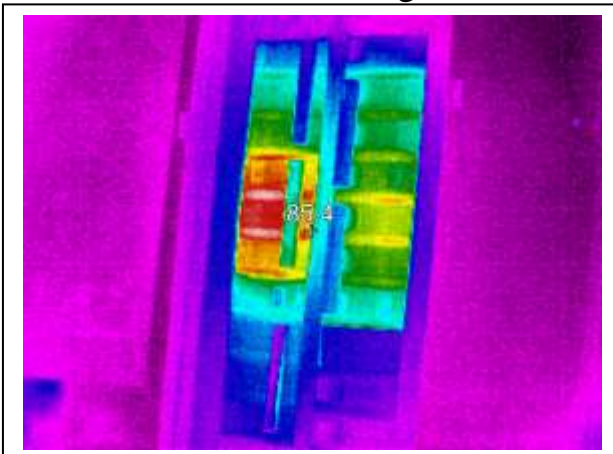
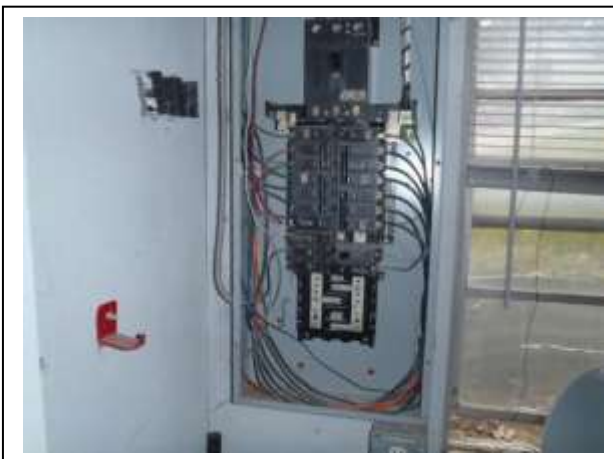
Thermographic Set #: 4

One circuit showed a Priority One temperature increase (over 50 degrees F), located at the Laundry Room Service Disconnect, AC Unit #2 Phase 2. The issue noted there (loose connection) was addressed during the scan (by [REDACTED]).

Location: Laundry Room

Panel: Service Disconnect

Circuit/Fuse Designation: AC Unit #2, 2nd Phase

Anomaly Temp: 165 F at wire,
106 F at breaker

Ambient Temp: 80 F

Temperature Differential: 85 F at
wire, 26 F at breaker.

Priority Scale: 1

Comments: 1st Infrared Image depicts an 85 F temperature rise at the wire connection to the breaker. The connection was found to be loose, and tightened by [REDACTED] during the scan. The breaker panel was re-scanned one hour later, noting a significant temperature reduction at the breaker, from 106 F to 86 F.

Circuits listed with temperature increases of 50° F and higher are marked as PRIORITY 1 and should take top priority in electrical repair service. Parts will often require replacement due to thermal stress. Attempts to simply tighten connections will probably not offer permanent repair.

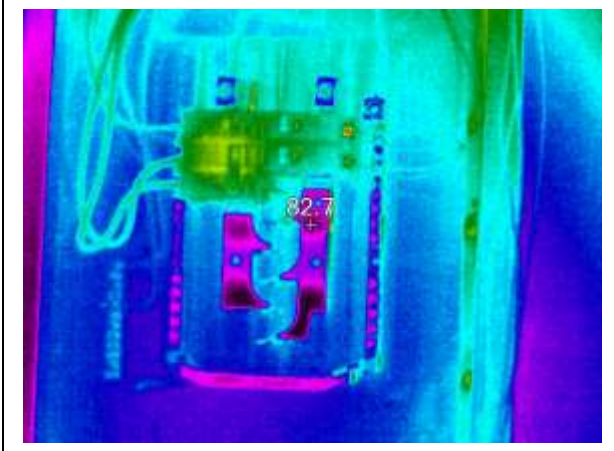
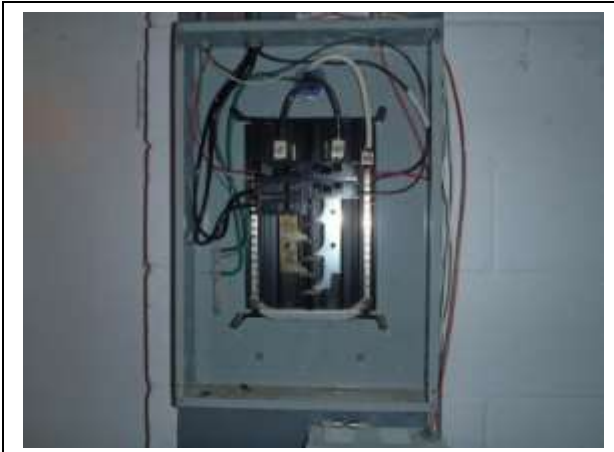
Thermographic Set #: 5
Location: Food Storage Pantry
Panel: Circuit Panel
Circuit/Fuse Designation: --
Anomaly Temp: --
Ambient Temp: 84 F
Temperature Differential: --
Priority Scale: x

Comments: No increases noted here.

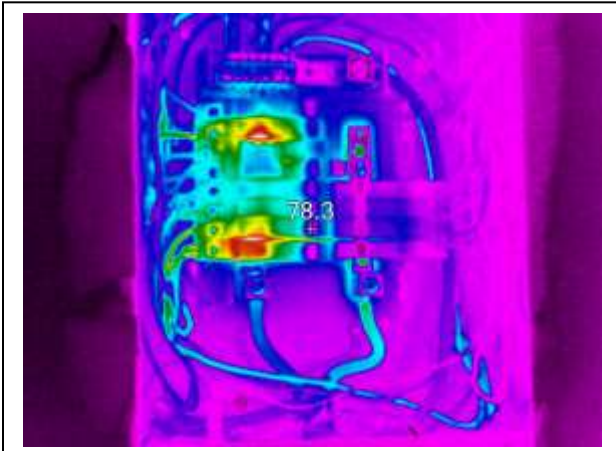
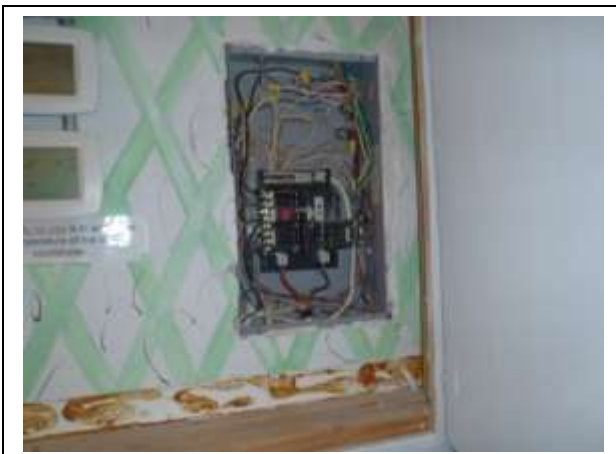
Thermographic Set #: 6

Location: Nurses Office

Panel: Circuit Panel

Circuit/Fuse Designation: #3 and #9

Anomaly Temp: #3- 94.7 F.
#9- 94.1 F

Ambient Temp: 77 F

Temperature Differential: #3- 17.7 F,
#9- 17.1 F

Priority Scale: 3

Comments: Minor increases seen here.

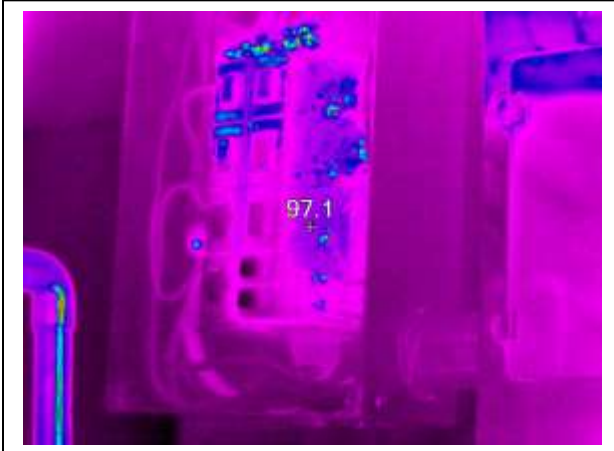
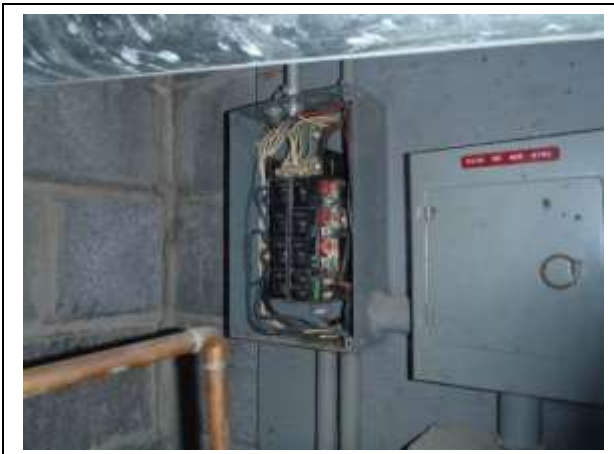
Thermographic Set #: 7

Location: Boiler Room 5

Panel: Lighting Panel New Wing

Comments: All circuits and wiring without temperature increases.

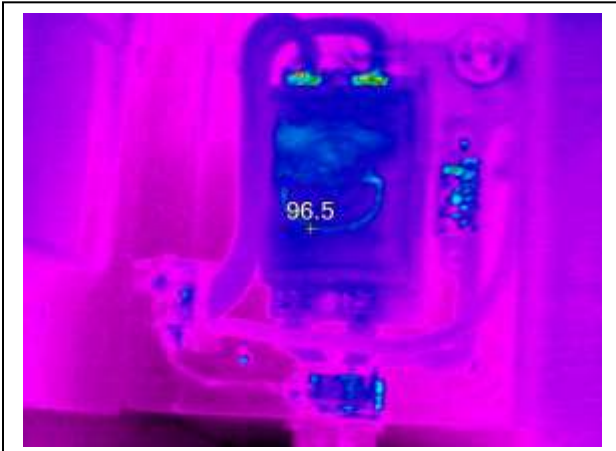
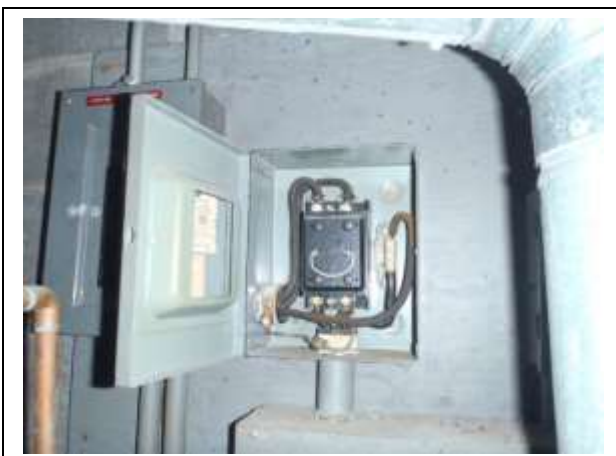
Thermographic Set #: 8

Location: Boiler Room 5

Panel: Main SW New Wing

Comments: No issues noted.

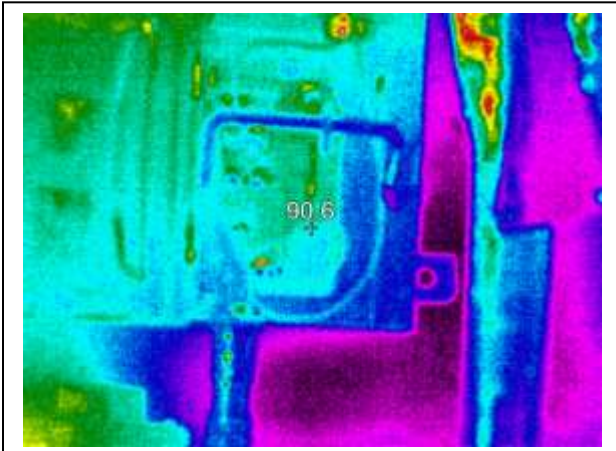
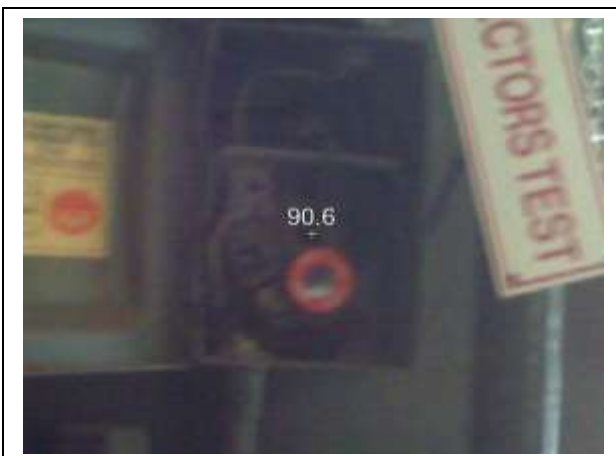
Thermographic Set #: 9

Location: Boiler Room 5

Panel: 20 Volt Receptacle

Comments: Box empty, no fuses within box.

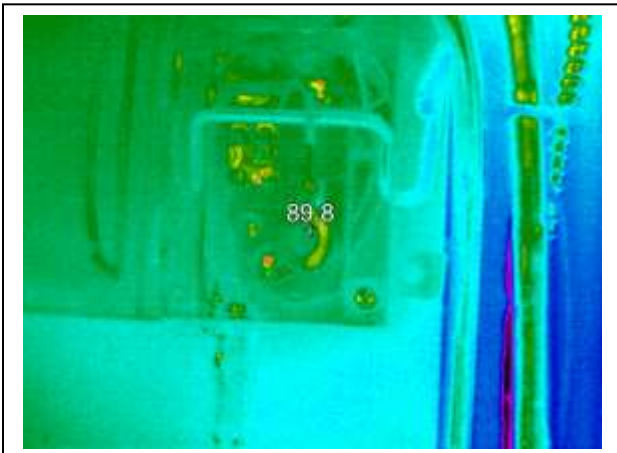
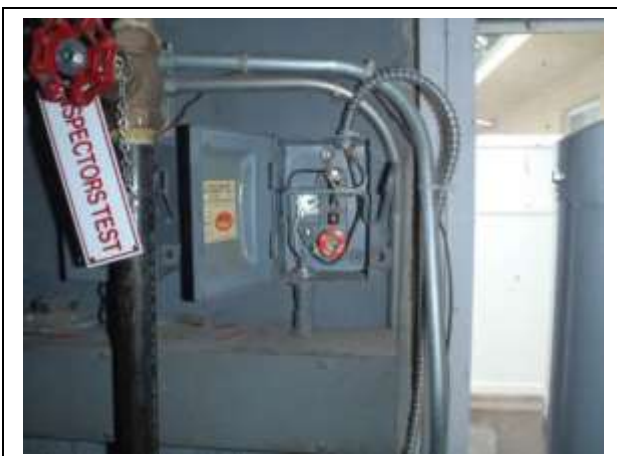
Thermographic Set #: 10

Location: Boiler Room 5

Panel: Transformer Heating System

Comments: No issues noted.

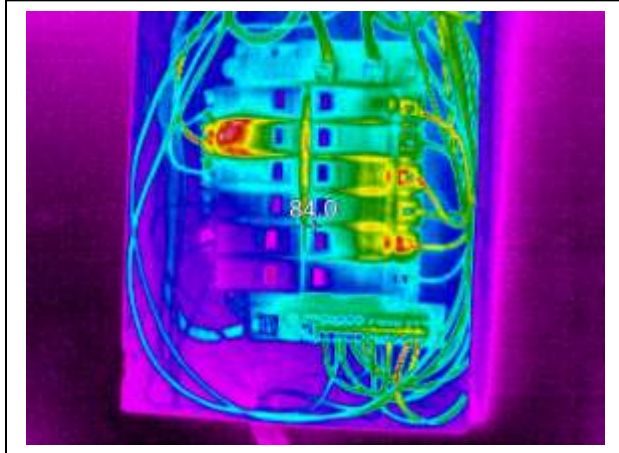
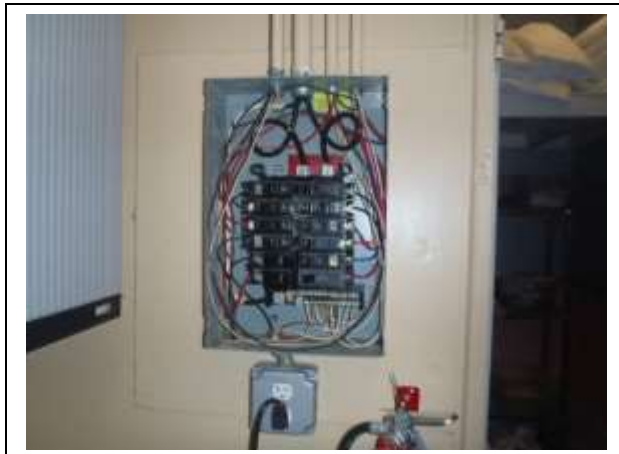
Thermographic Set #: 11

Location: Boiler Room 5

Panel: Water Heater Box

Circuit/Fuse Designation: #3

Anomaly Temp: 90.5 F

Ambient Temp: 82.1 F

Temperature Differential: 8.4 F

Priority Scale: x

Comments: Slight increase, below criteria for Priority Scale 3. Likely a normal usage increase.
